Water Quality Assessment Report (TAR) **2023**

Joe Musante
Water Resources Program
Environmental Department
Indian Township Tribal Government

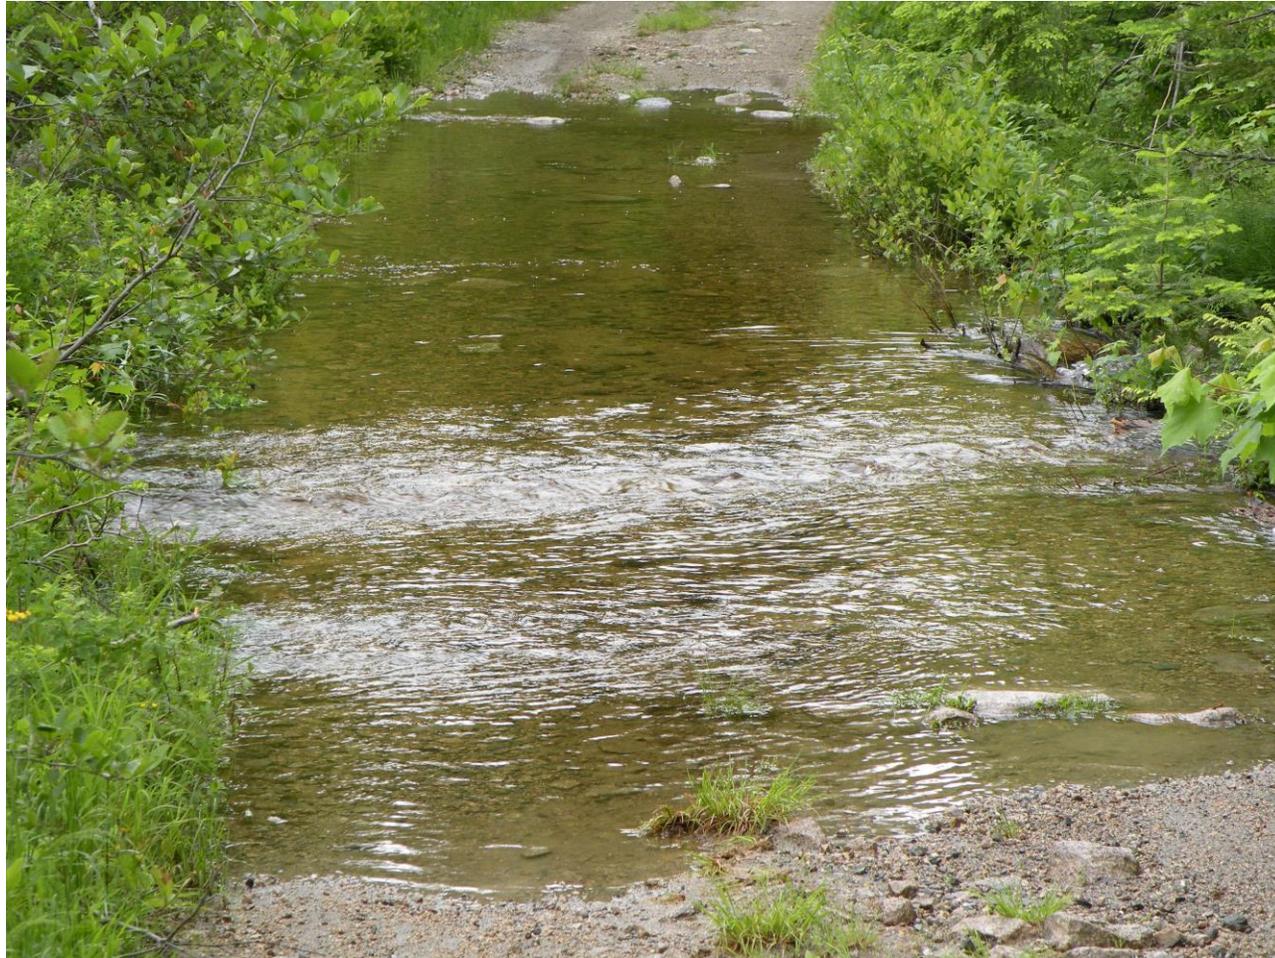
Situations like a blocked culvert shown here cause water to run over roads, picking up sediments that will reduce a lake's transparency.

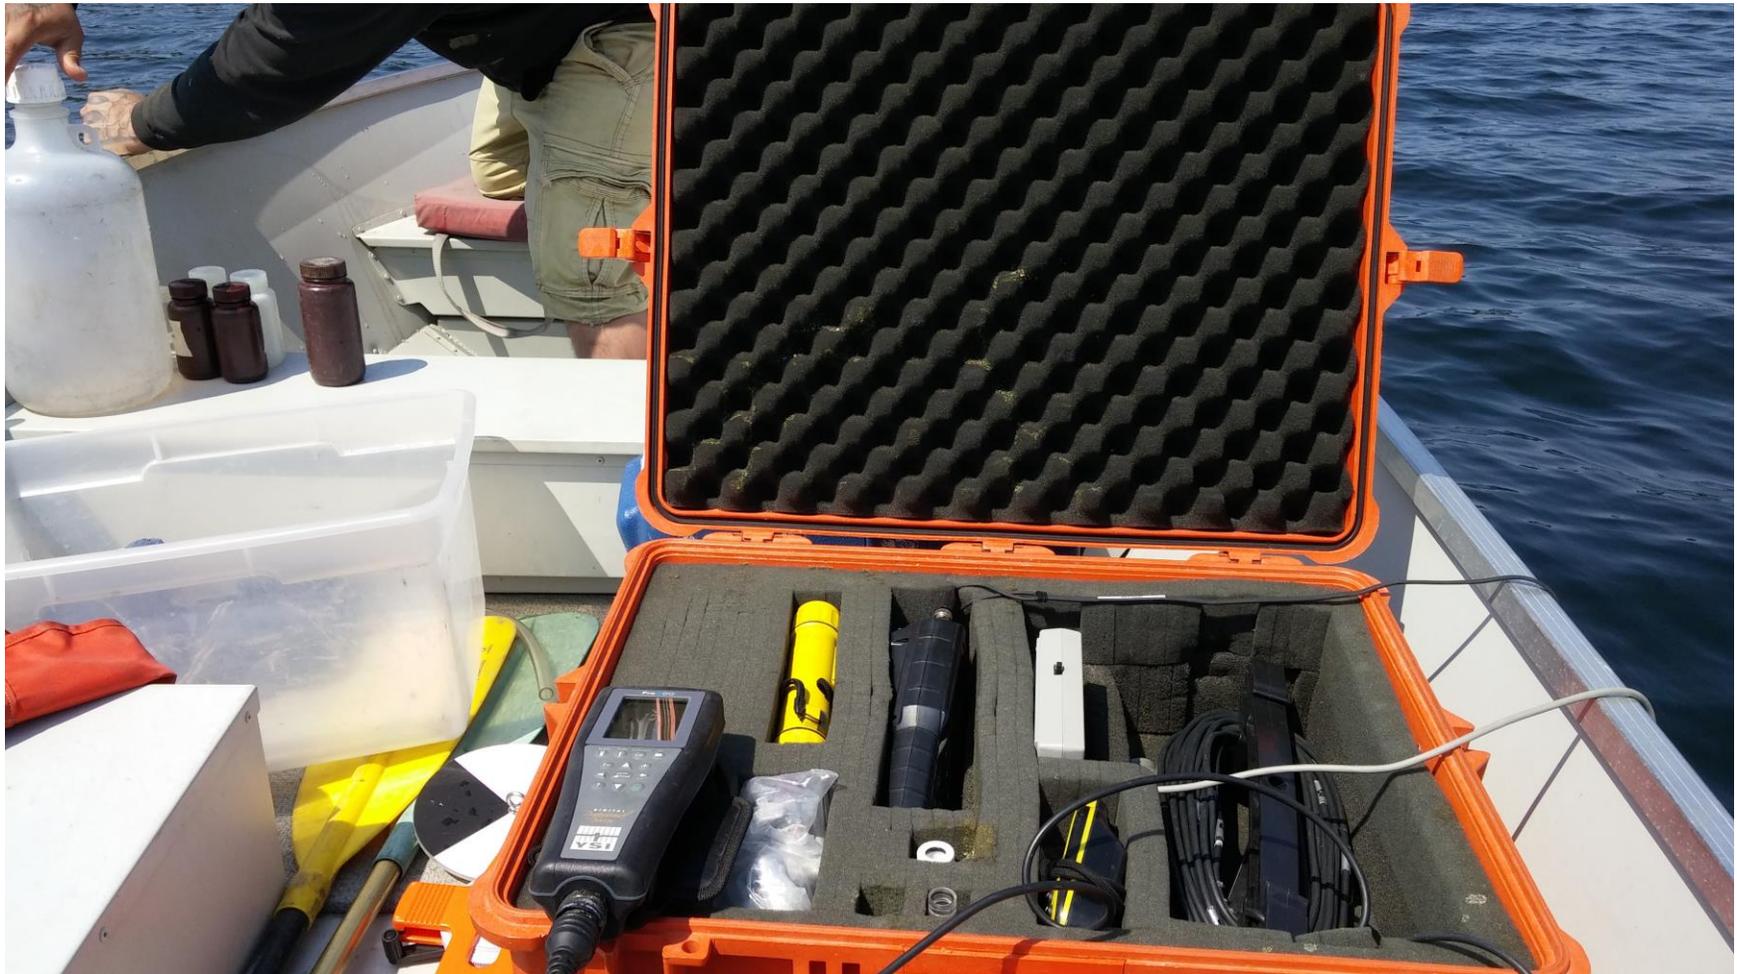
Our remote floating lake 'lab' hard at work. Testing around the West Branch of the St Croix every summer.

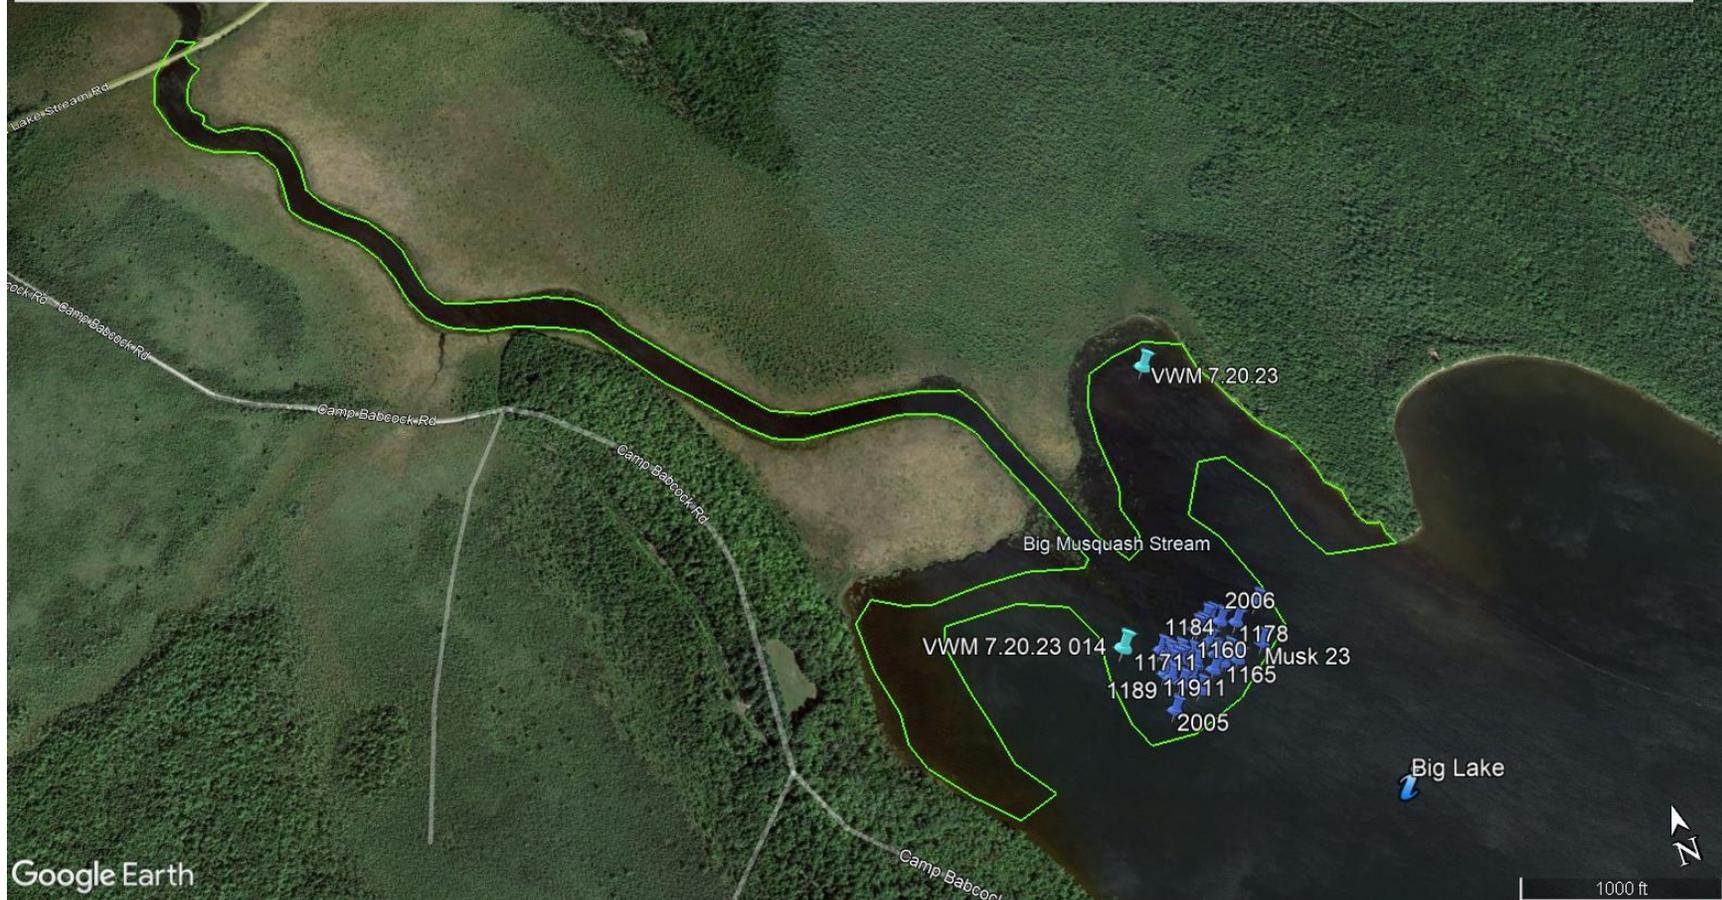
The mouth of big musquash stream is the next largest infestation of VWM in the system outside of Clifford Bay. This area was worked on by NEMilfoil's DASH crew for most of the season and will be a focus for years to come.

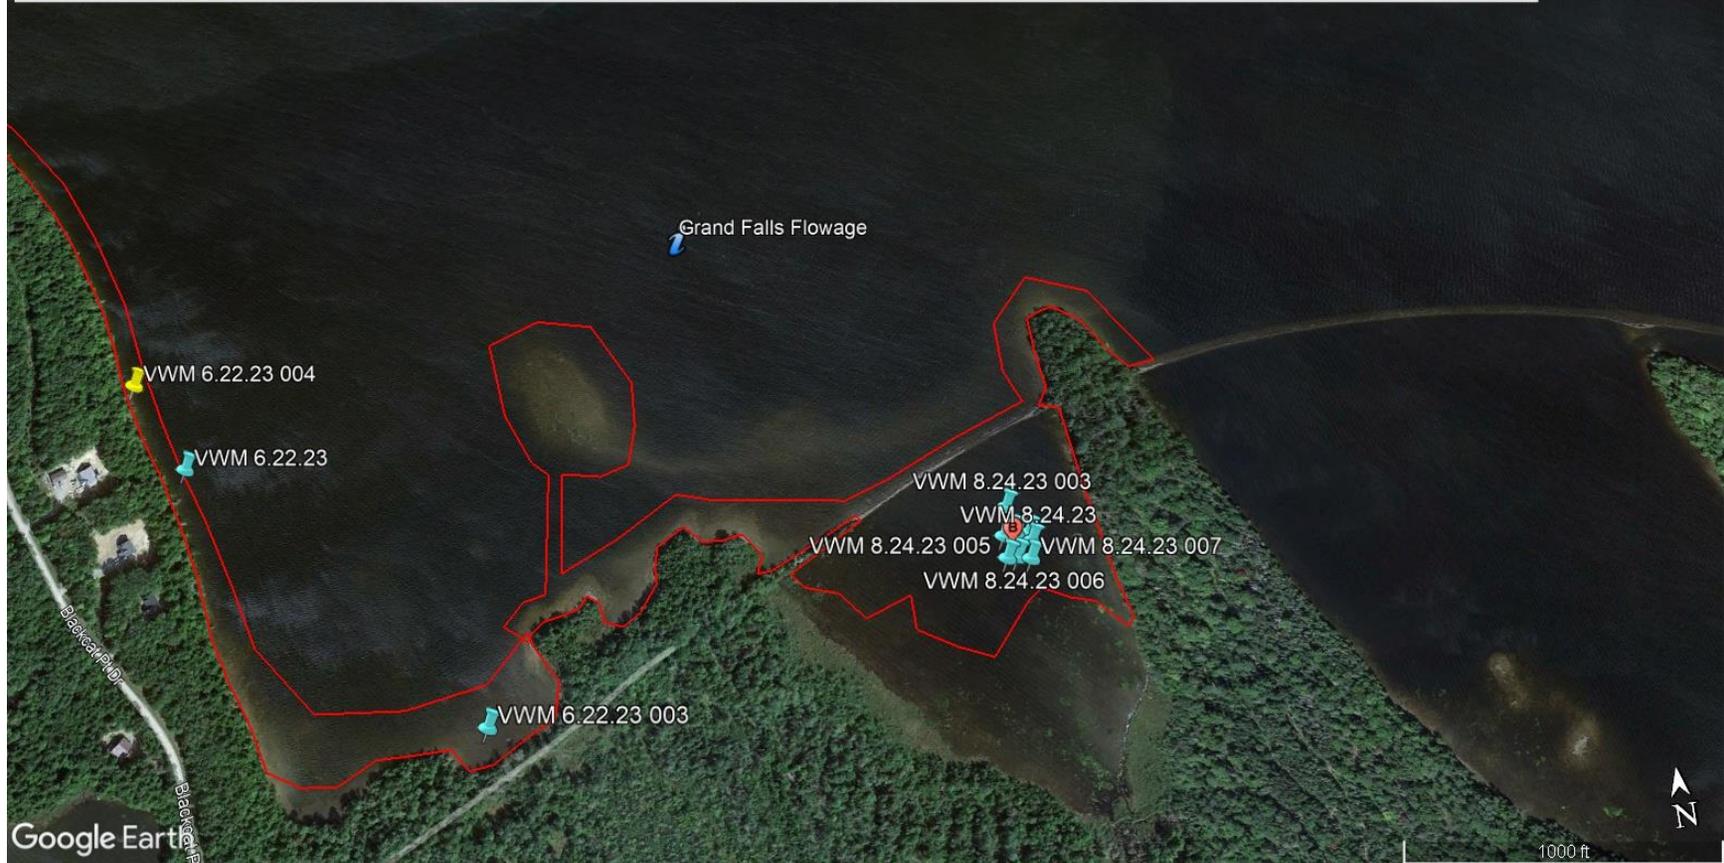
Grand Falls Flowage: Causeway

Red: Pre-Removal survey in one of the few areas not surveyed in 2022 in this end of GFF. Surprisingly a series of small but dense patches of VWM were found behind this flooded railroad causeway on 6.23.23. The area is only barely accessible by small boat in high water levels. PIT returned to remove the VWM on 8.24.23 only to find many more small plants and lower water. Two benthic barriers were dropped on dense areas and lots of plants were removed from the very soft bottom. We were unable to get back before the water levels got too low to access, it turns into a pond at low water. Will need to be finished in June before water levels are too low to allow boat access.

These locations mark the furthest found VWM downstream in Grand Falls Flowage. Seeing how extensive the population was behind the old railroad bed, we'll be resurveying the next cove down in 2024.

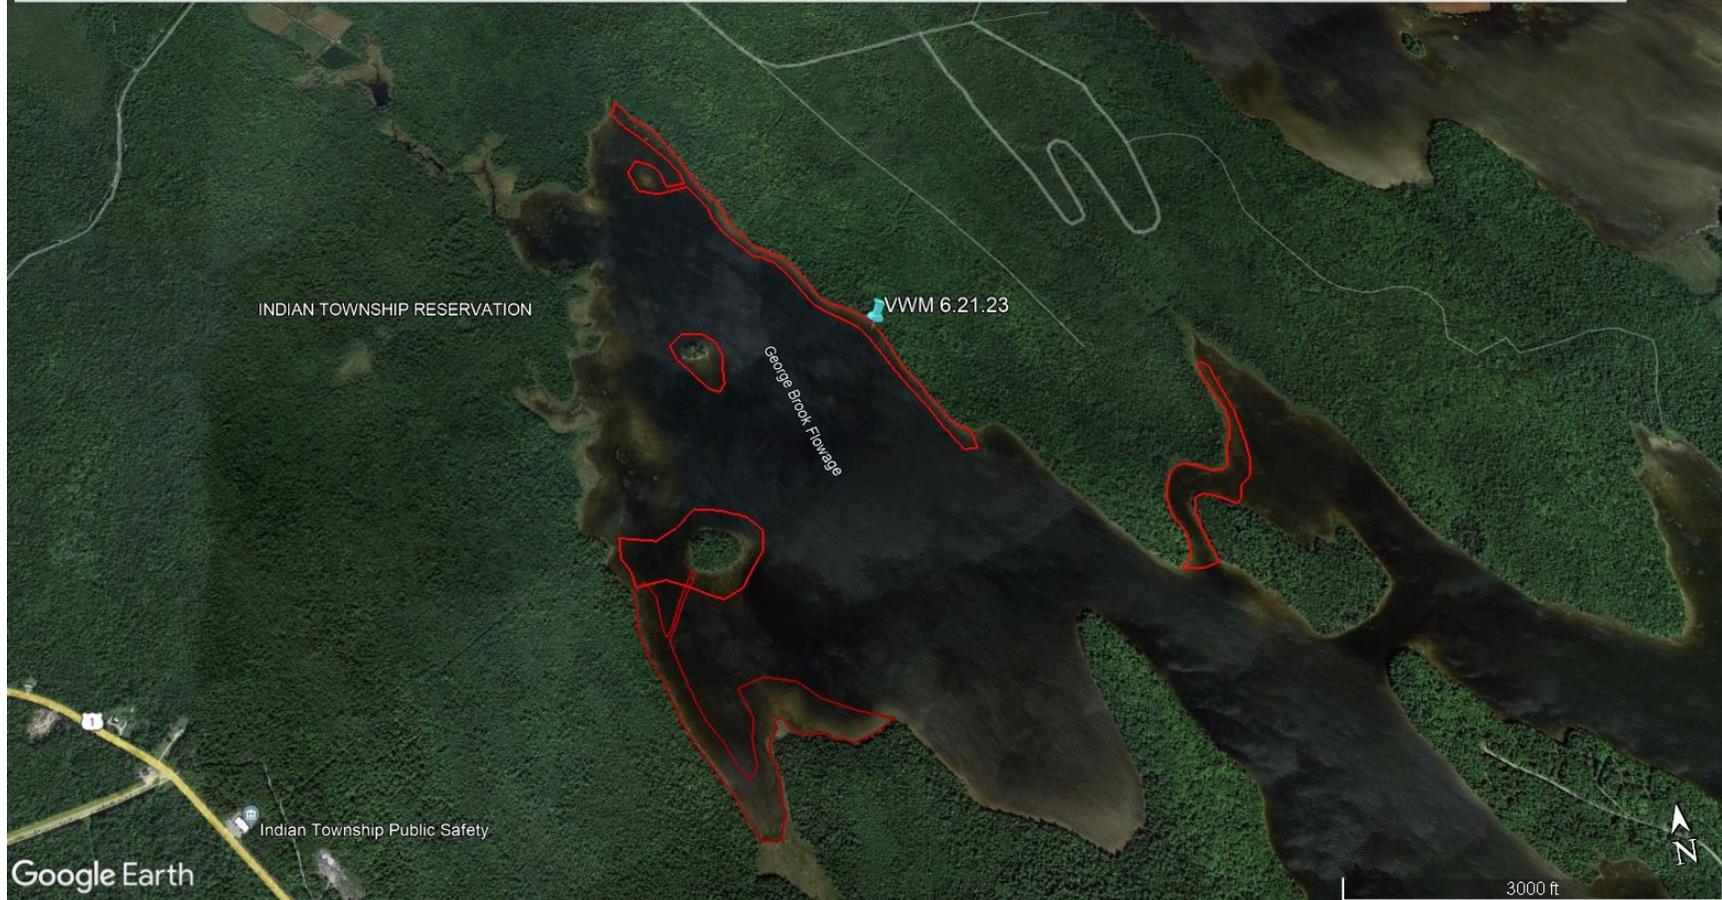
Red: Pre-Removal survey in one of the few areas not surveyed in 2022 in this end of GFF. There is still some initial survey work to be completed in May on the western shore up to George Brook before plants get thick. Two individual VWM plants were found on the Eastern shore at VWM 6.21.23 by PIT staff and were removed in early October. More survey work will need to be done to make sure this Flowage doesn't get any established VWM.

The northwestern shore of George Brook Flowage still needs its initial survey, one small pair of plants were found on the eastern side mixed in with downed wood along the lake bottom.

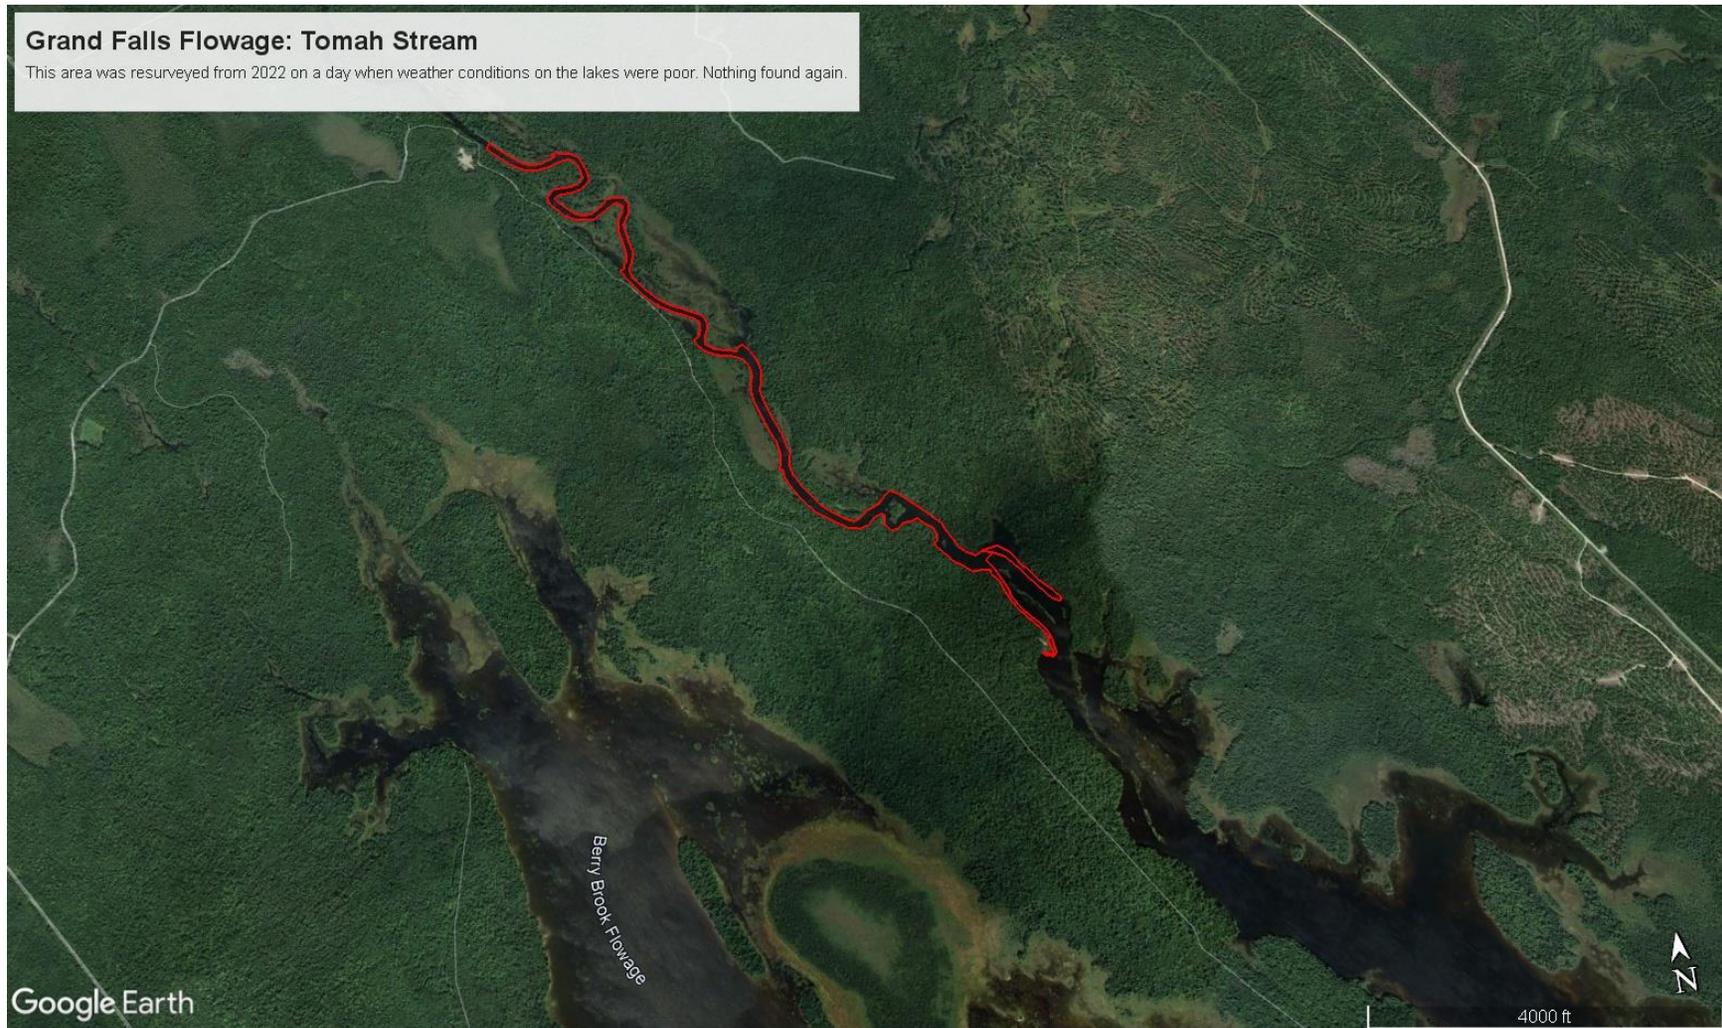
The red survey area also shows the reach of Tomah Stream that is inundated due to the Grand Falls Dam downstream. Not far above the red are natural stream conditions too rocky for motorboat travel.

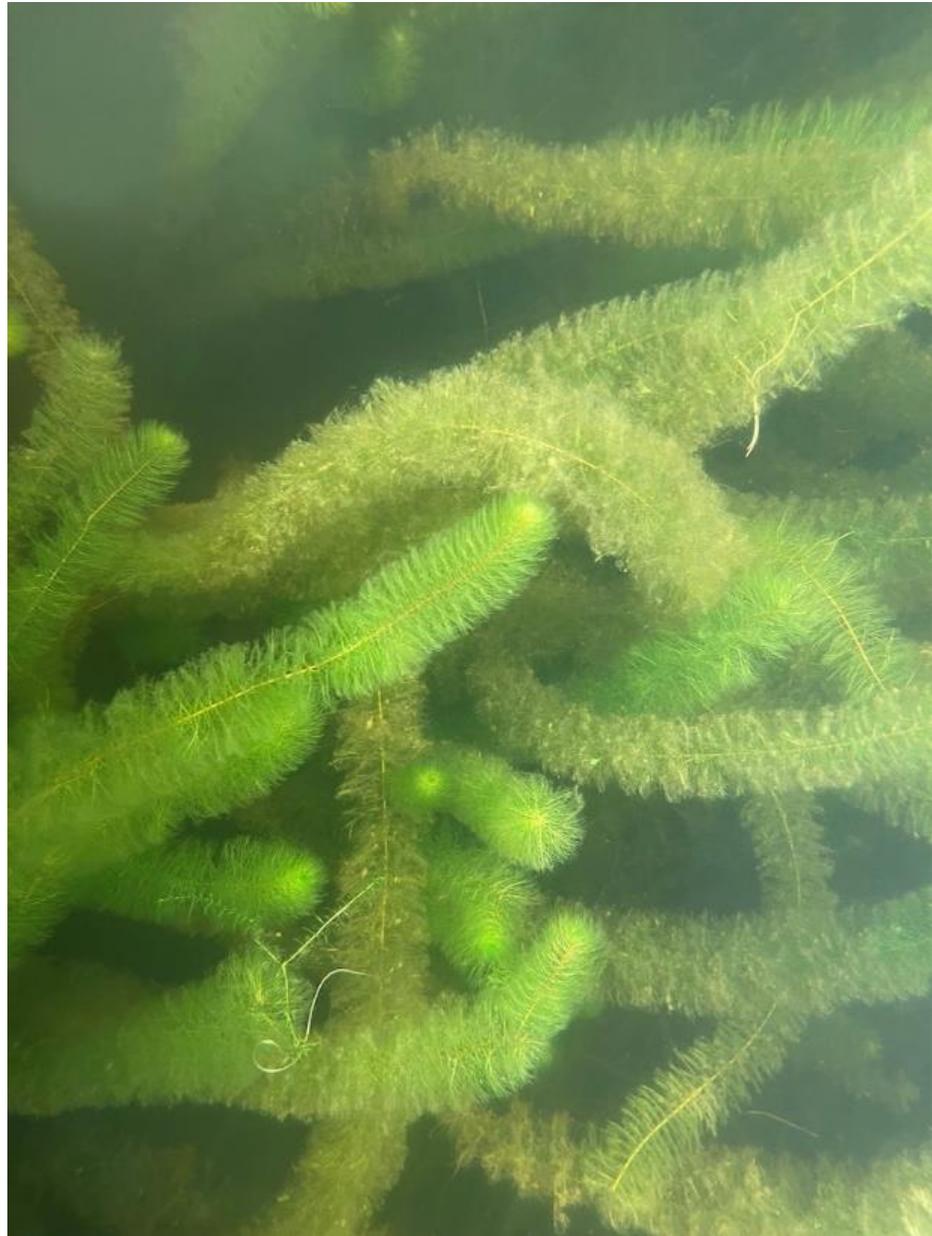
The picture to the right shows some fresh green growth on VWM, along with some new roots forming along the older growth. These older stems vegetatively reproduce in two ways. One: fragment in the spring or fall and float off to sink and root in a new location. Two: they will also lay down in place, still attached to the mother plant, and root all along the stem. Then from there they put up new vertical stems all along the length of the old stem. Think of it like an old tree that blows down and sends up new shoots all along its trunk. This form of spread creates dense monocultures in a location, while the fragmentation helps colonize new areas, perhaps miles and miles away. Both methods produce genetically identical plants.

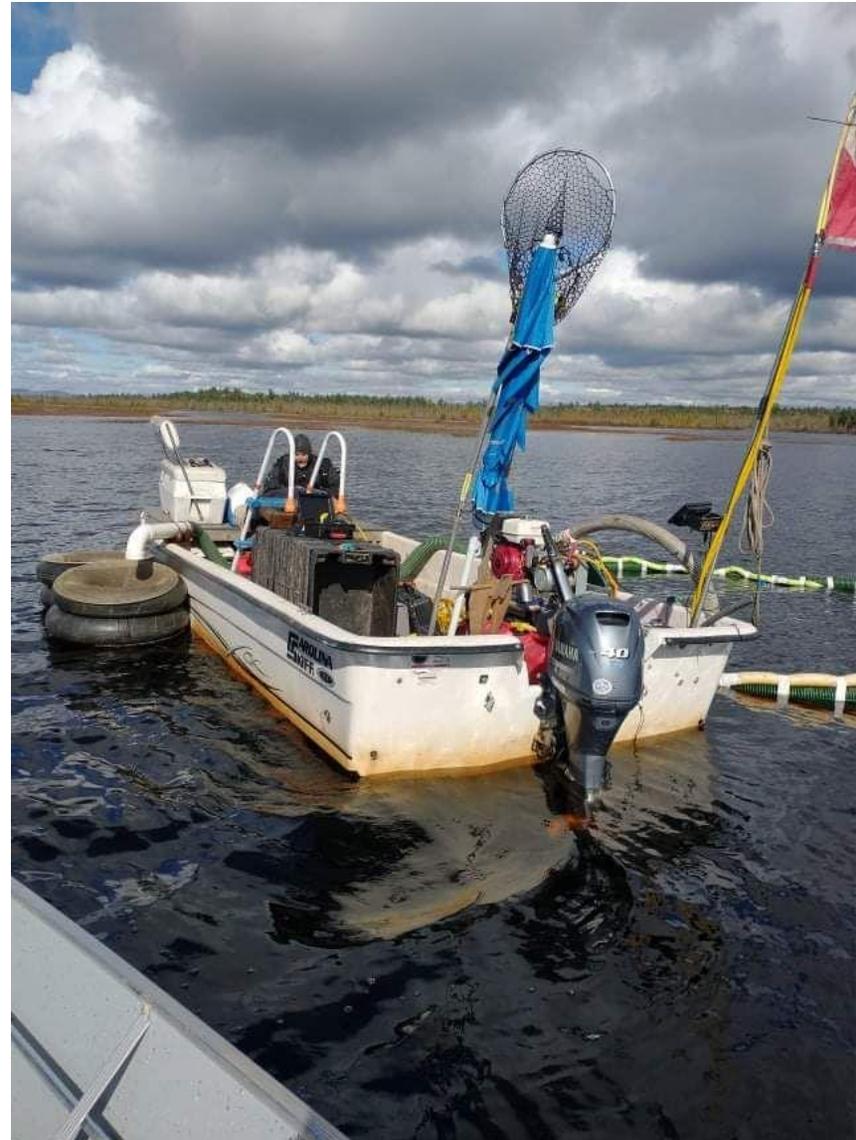
A scuba (or surface supplied air as in this case) diver digs and pulls up rooted vegetation on the lake bottom, feeding it into a vacuum nozzle, giving the invasive VWM a quick ride onto the boat. The water and material dump over the side of the boat through a mesh net, capturing all the plant material, and flushing the water and sediment back into the lake. This suction harvest system gives the diver much higher work efficiency than a hand pulling diver since they can remain on target the entire dive. A hand pulling diver must surface to shuttle material to the support boat. This not only saves dive time, but also helps with preserving some of the precious visibility lost during ascent and descent.

As the plant material piles up onboard, the deckhand fills 10 gallon fish crates and stacks them on the deck. The more deck space the more material can be stored before having to head to shore to offload. DLLT has purchased a dump trailer and contracted to have it emptied weekly in a gravel pit for safe composting.

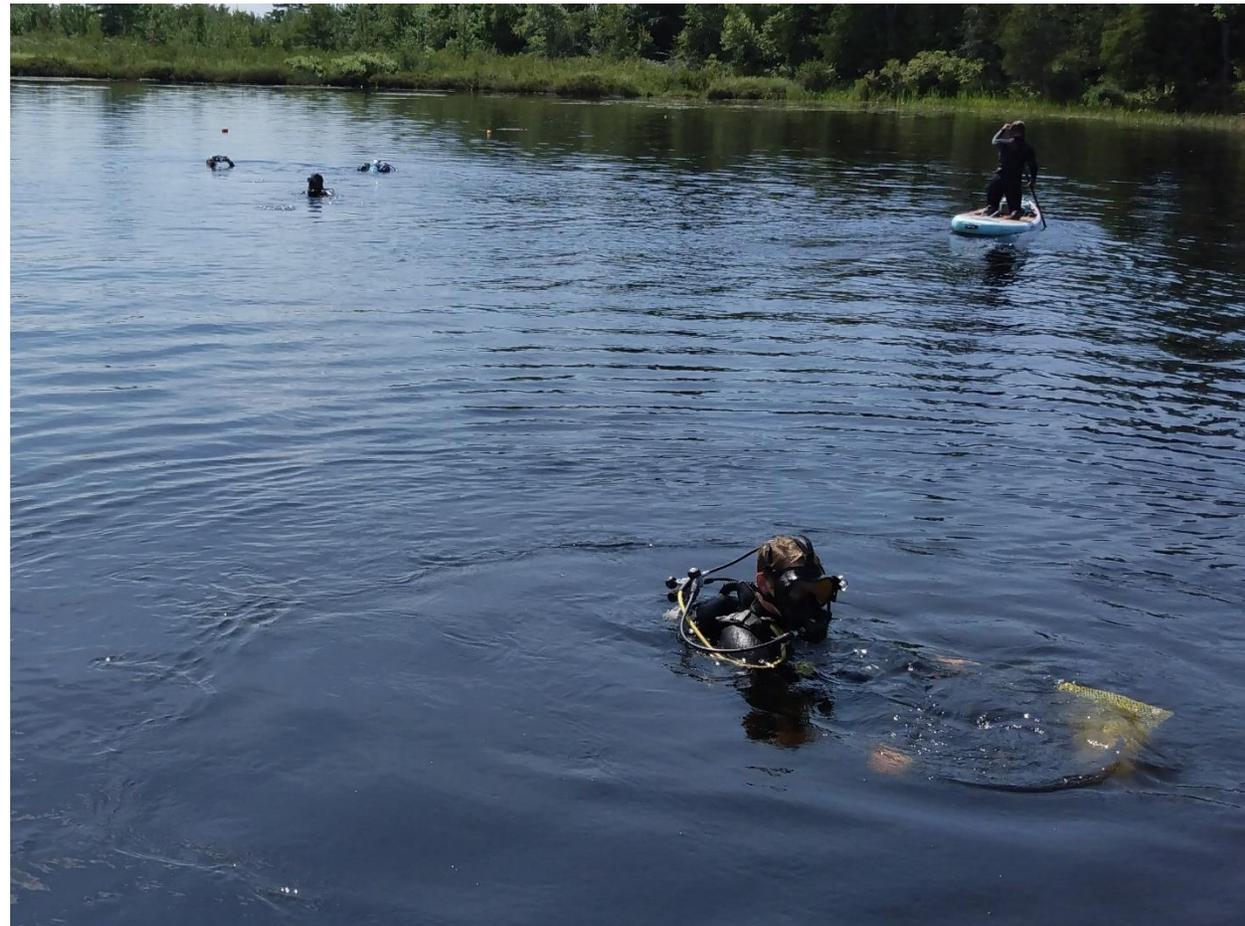
The second piece of DLLT removal contribution was the organization and support of the Combat Wounded Veteran’s Challenge (CWVC). *Combat Wounded Veteran Challenge is a Florida based, national non-profit organization dedicated to improving the quality of life for our returning American combat wounded and injured military service veterans. The basis for our mission centers upon 3 core principles – Challenge, Research and most importantly Inspire.* CWVC and its two dive teams spent part of the second week of August being trained and then removing VWM in Long Lake for three days. Divers were divided into morning and afternoon teams made up of 4 divers each. Divers used SCUBA gear and hand pulling techniques to clear VWM marked by the tribal dive crew earlier that month. Their work helped clear the bulk of VWM sites marked in Long Lake for 2023. The picture below shows the afternoon dive crew working on VWM marked with buoys with paddle board support.
